## **HEAT AND POWER FOR BIRMINGHAM**

**SDRC-7**

**Installation and Open-Loop  
Tests of FLM Equipment**

**14.12.2015**

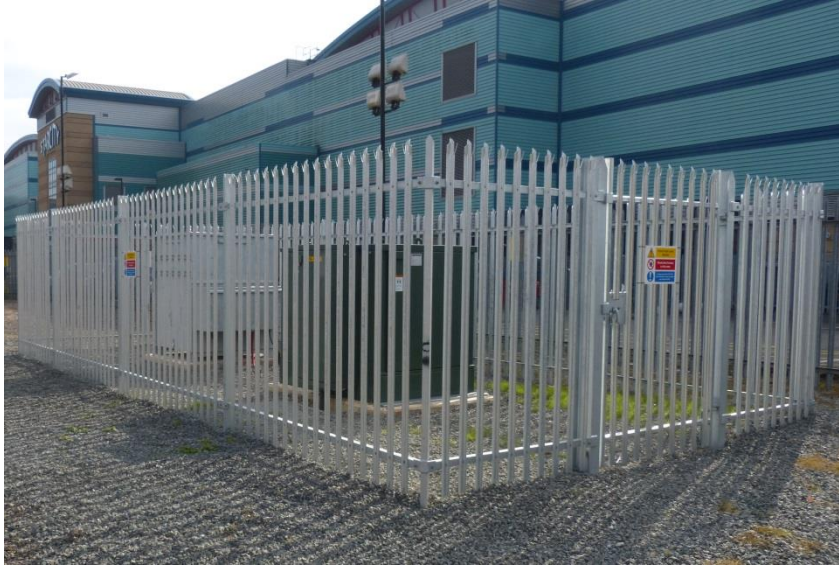
Figure 2-1 - PMIR and Resistor installed at Nechells West Substation

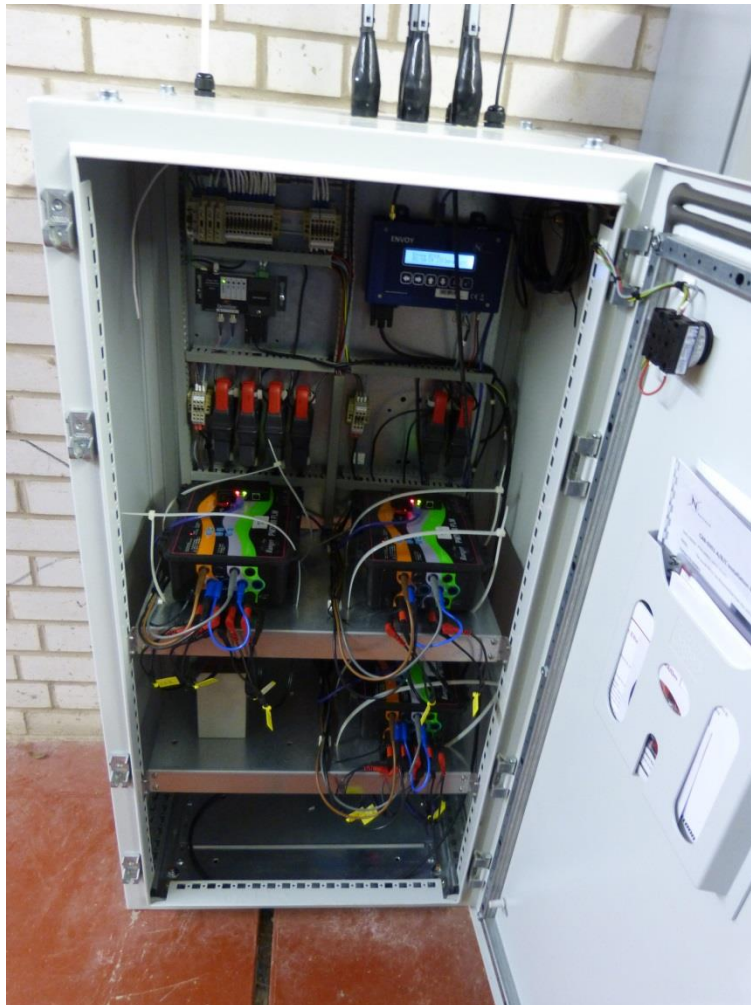
Figure 2-2 - 3 off PM7000s and Envoy installed in FLM Control Cubicle

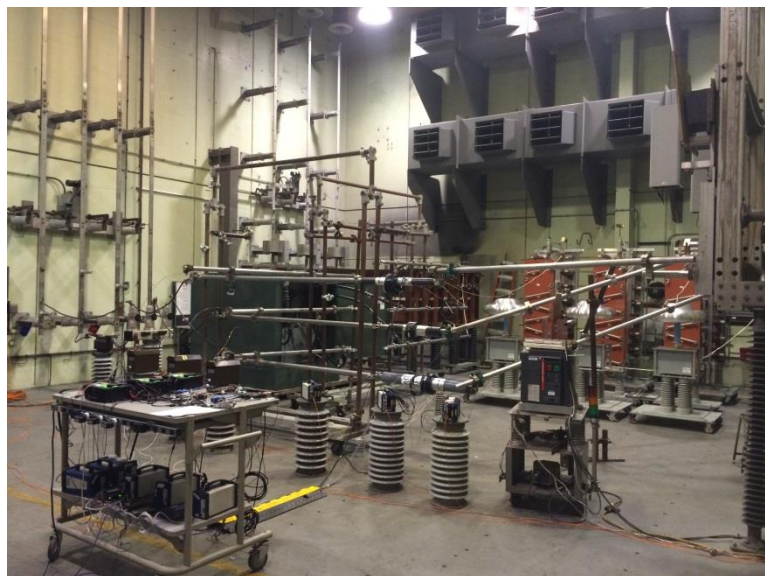
**Figure 4-3 - Test Lab during FL Tests**

Prior to the test of the FLM being carried a 3-phase bolted fault was carried out in the laboratory, tests 1, 6 and 11. These tests enabled a clear understanding of both the make and break fault levels of the laboratory network created. A series of artificial disturbances were created, through different resistance values, 20 $\Omega$ , 30 $\Omega$  and 50 $\Omega$ , and the results were captured. A photograph of the laboratory can be seen in Figure 4-3 and the results are presented in Figure 4-4.

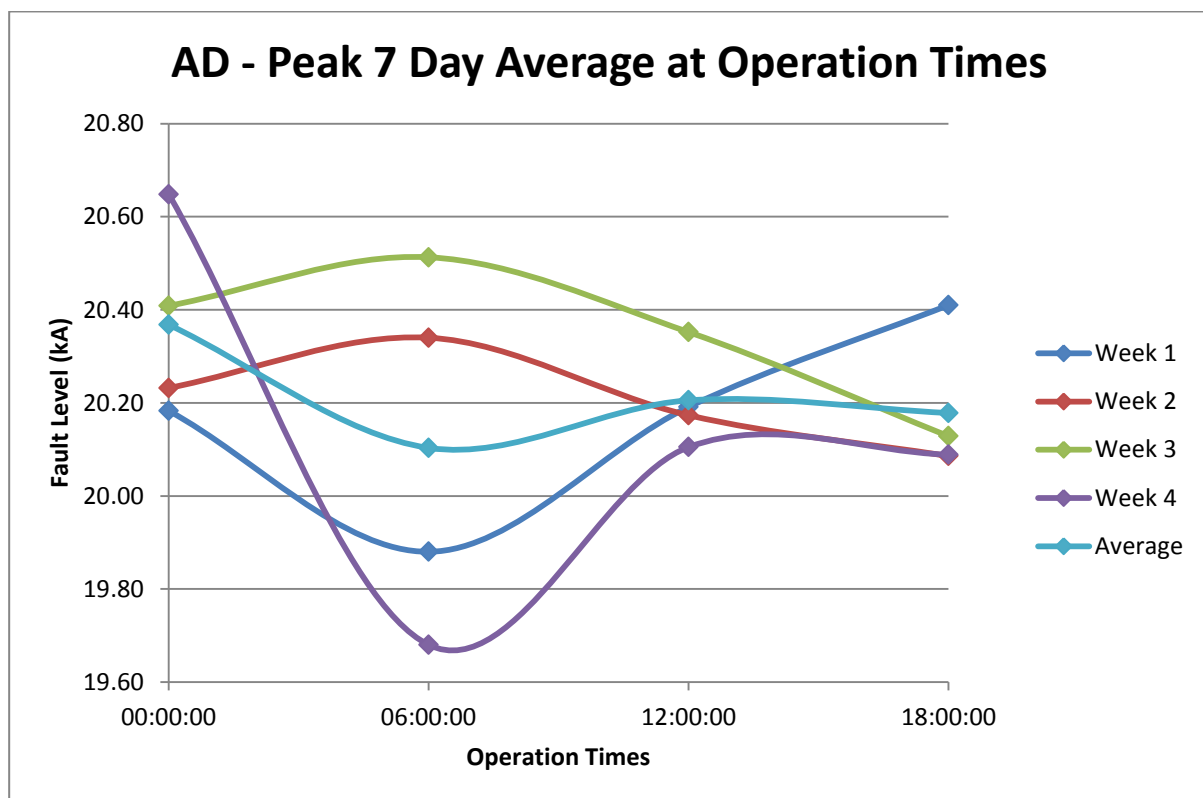
Figure 7-1 - Peak 7 Day Average for the Month

Below is an overview of both Artificial and Natural Disturbance data for Elmdon Substation, where it is output as week averages over a month period (September 2015) to indicate the level of change experience in data.

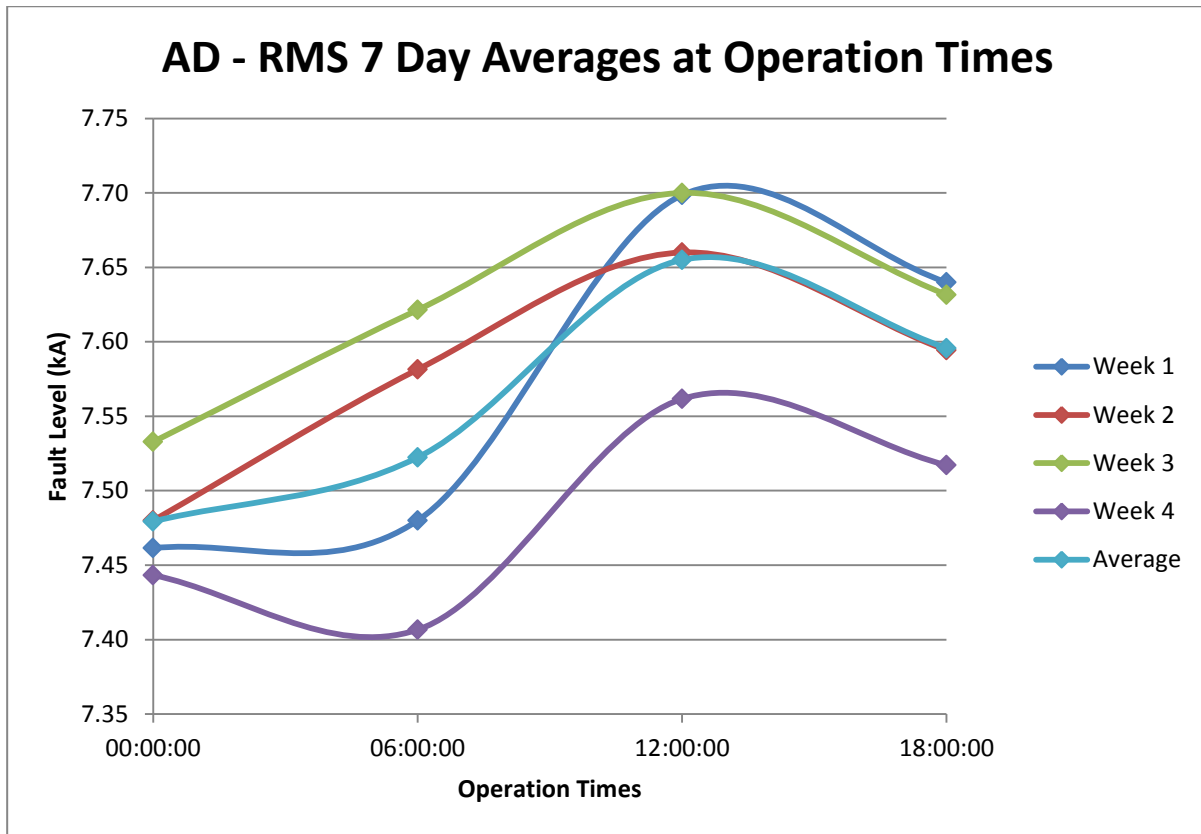
Figure 7-2: RMS 7 Day Averages for the Month

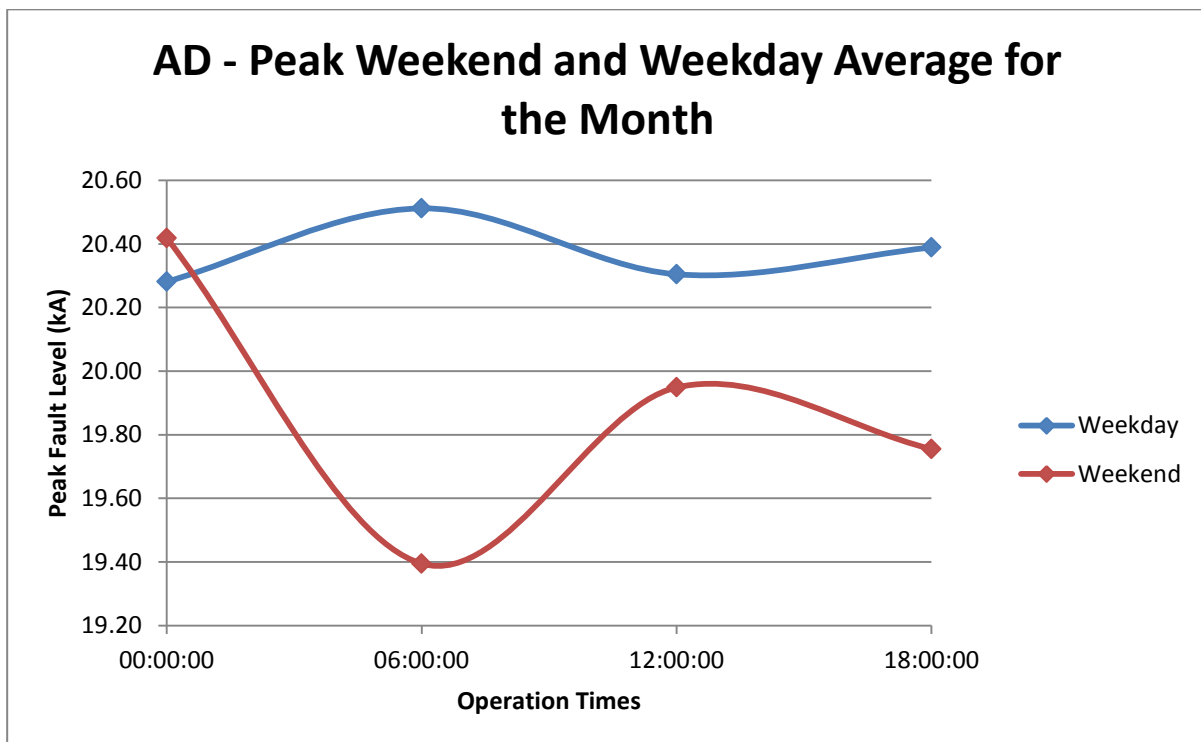
Figure 7-3: Peak Weekend and Weekday Averages

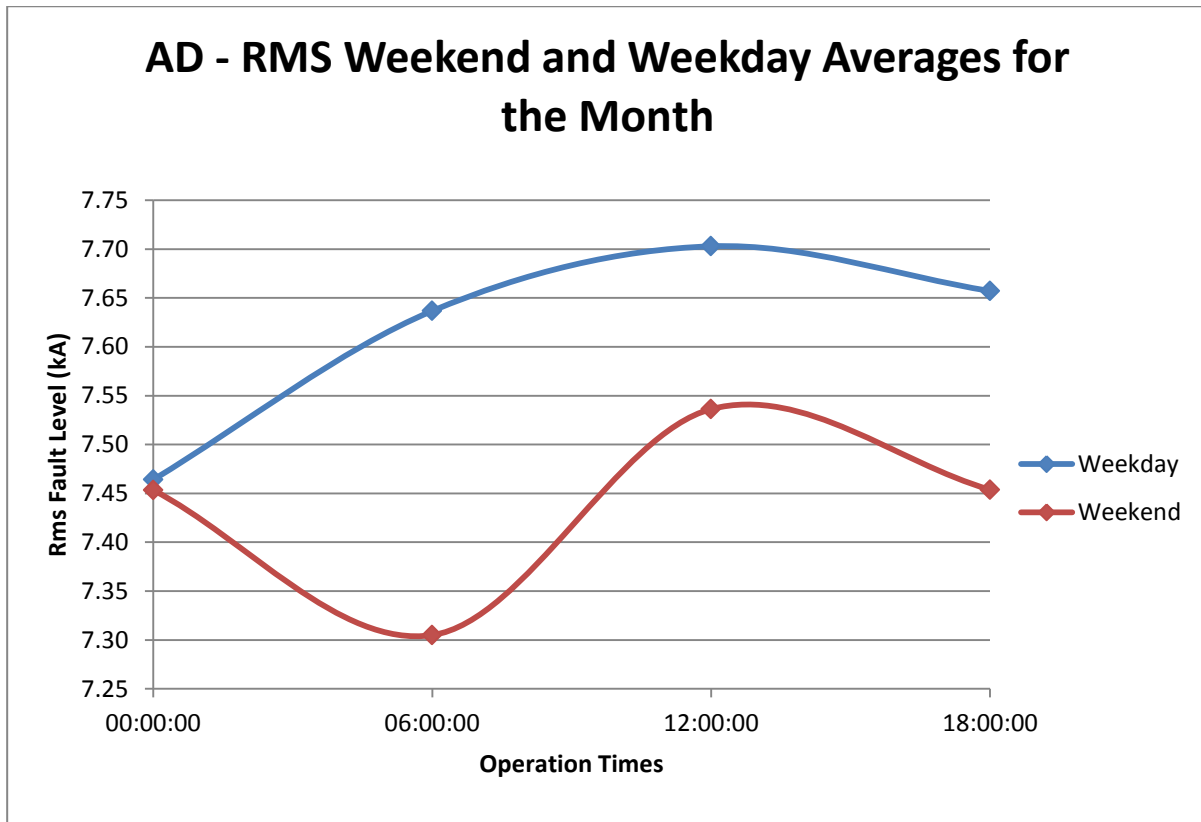
Figure 7-4 RMS Weekend and Weekday Averages

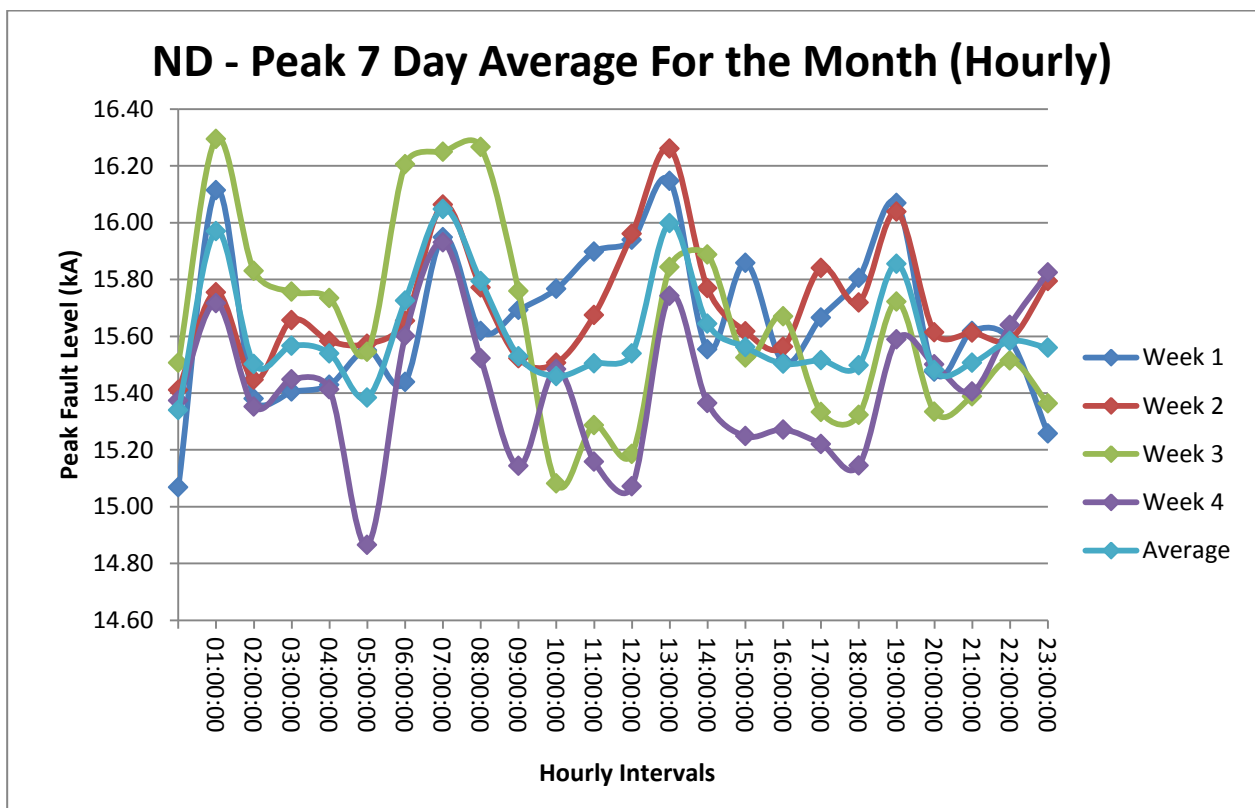
Figure 7-5: Peak 7 Day Averages for the Month for Hourly Intervals

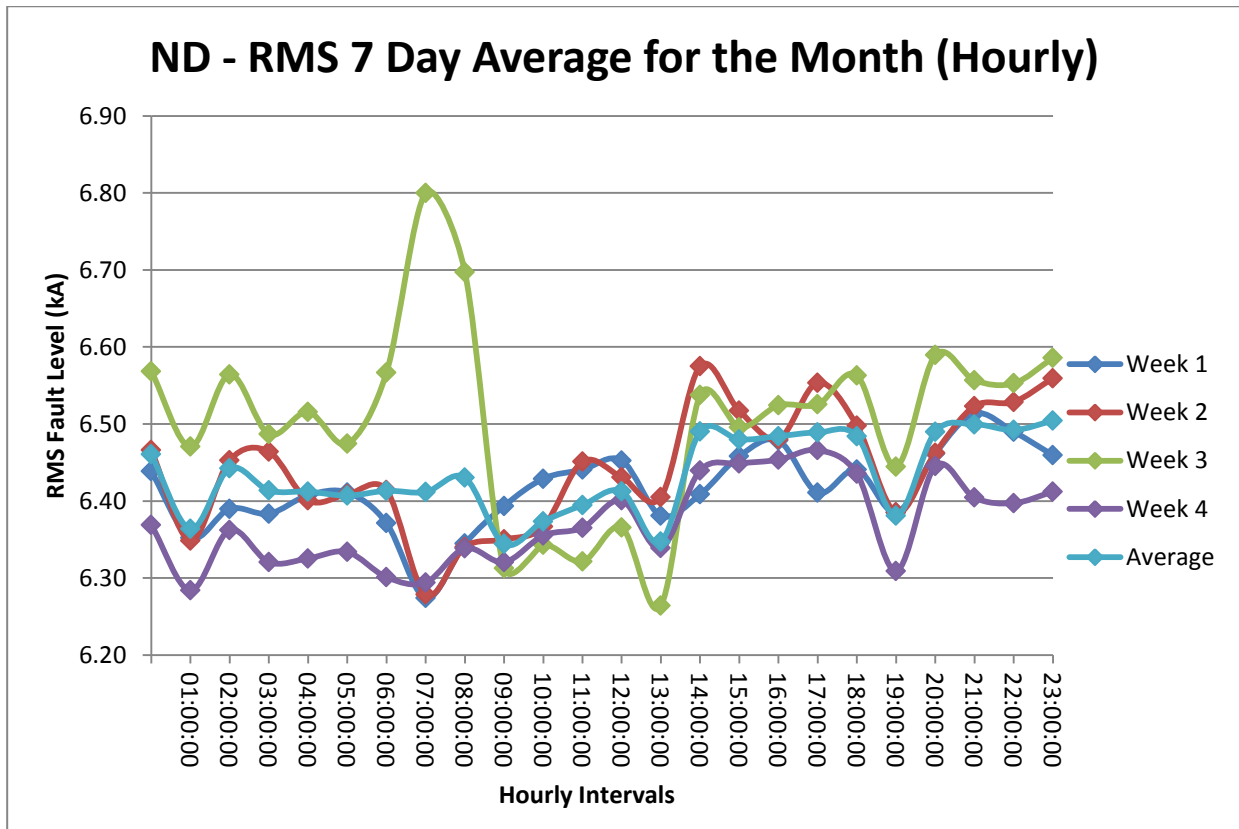
Figure 7-6: RMS 7 Days Average for the Month at Hourly Intervals

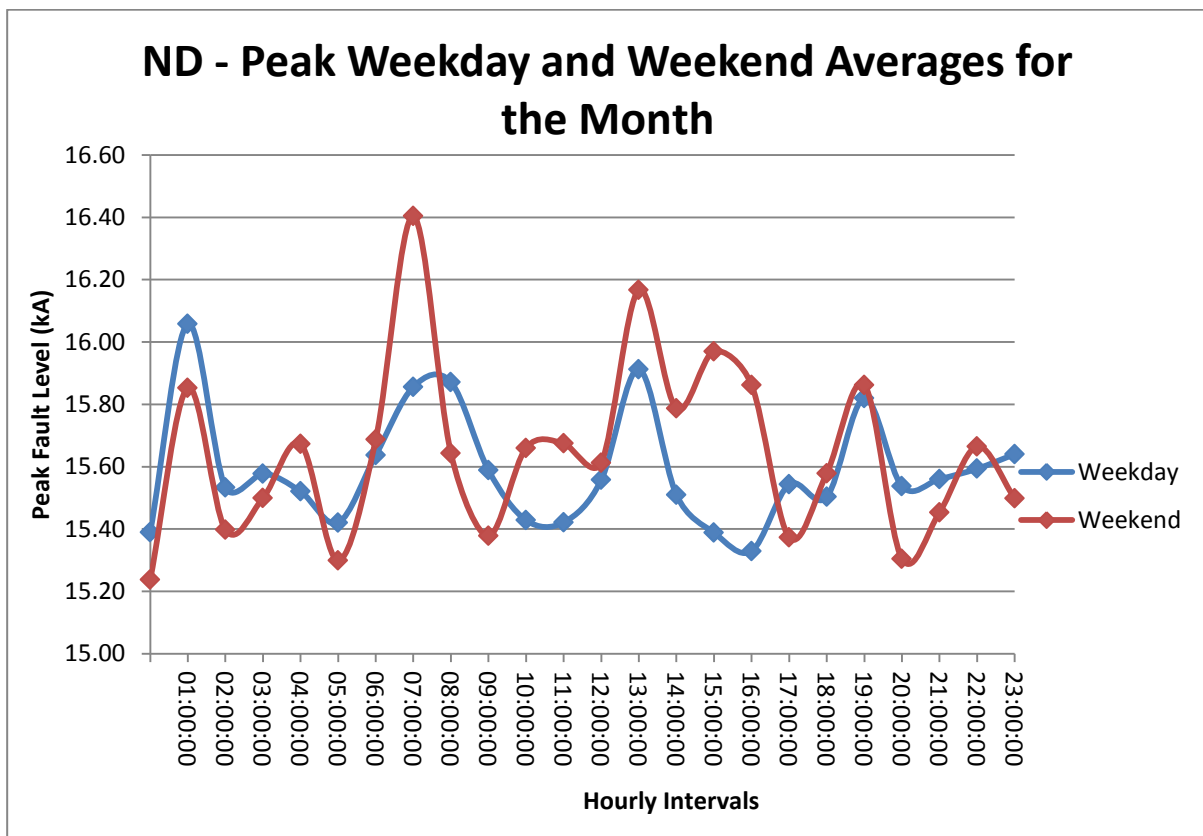
Figure 7-7: Peak Weekday and Weekend Averages for the Month

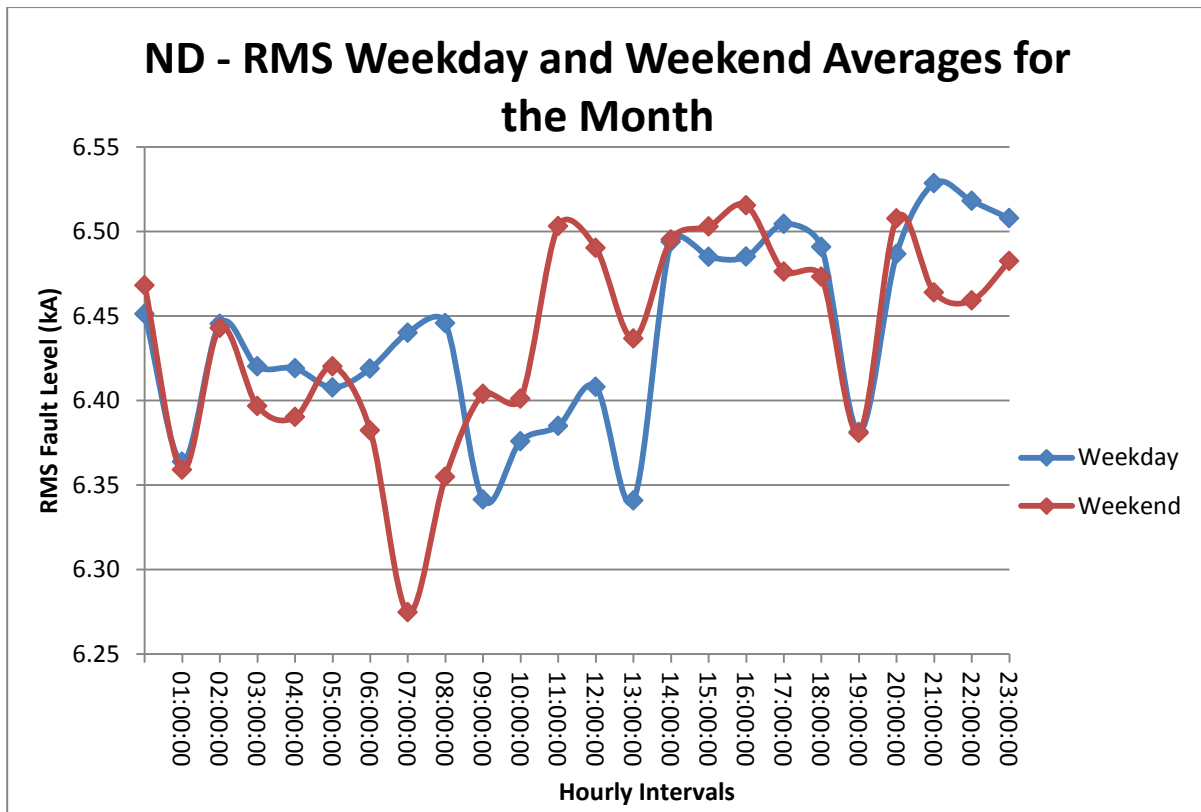
Figure 7-8: RMS Weekday and Weekend Averages for the Month

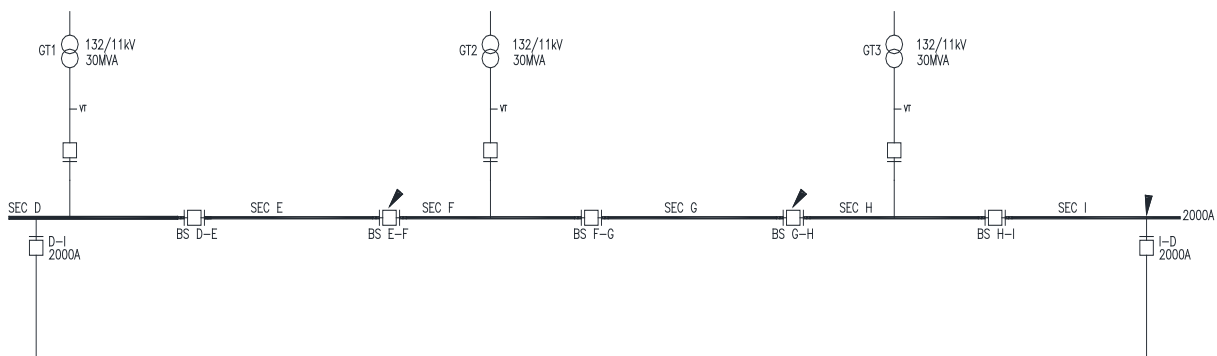
Chester Street 132/11kV substation is located to the north east of Birmingham City Centre and comprises 3 no. 132/11/11kV 30MVA transformers. The original substation was commissioned circa 1961 with an outdoor 132kV compound and all 11kV equipment inside a three storey brick building. The 11kV switchgear has recently been replaced and part of the building renovated.

Figure 2-1 - Original Chester Street SLD

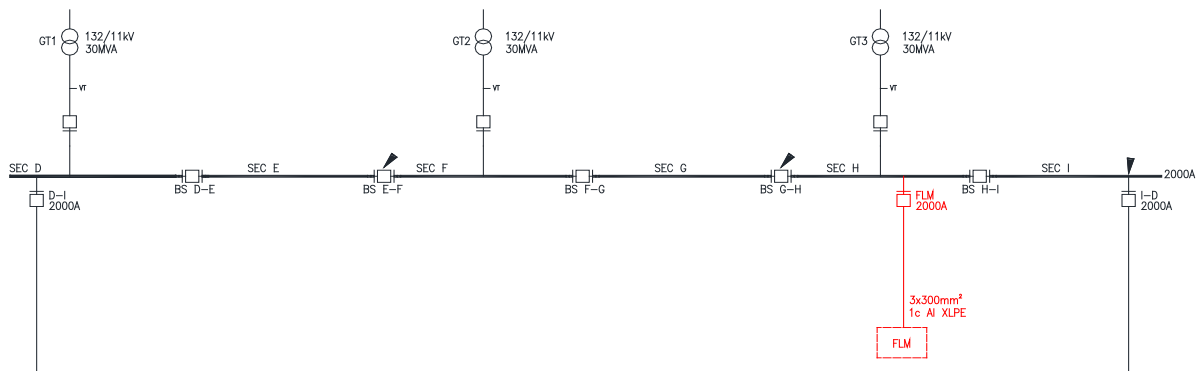
Chester Street substation was recently replaced with a new switchboard and as such a spare breaker was available. It was decided to utilise this breaker with the FLM placed just outside the 11kV switch house adjacent to the existing 132kV compound. The option of placing the FLM inside the building was explored but it was determined that access would be an issue and the cost would be too great compared to the external compound. The site was also selected for a Fault Current Limiter which meant we could create single compound for both devices.

**Figure 3-1 - SLD of FLM Connection**

As with the design for Shirley Substation, the Transformer Incomers do not contain metering CTs typically used for the current inputs to the FLM. Therefore, to get the CT inputs, the back-up protection CT wiring will be diverted to loop inside the FLM controller.

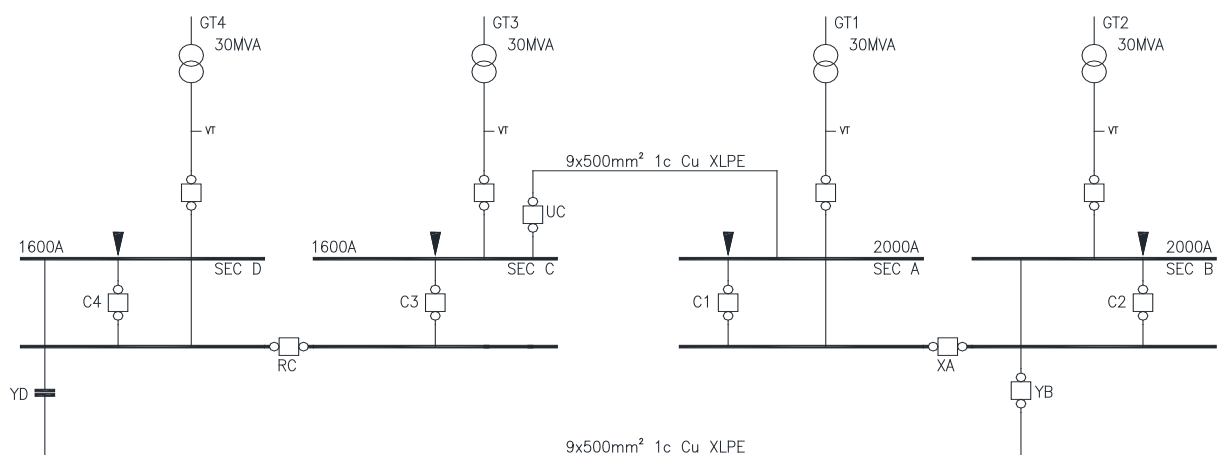
Bournville 132/11kV substation is located 5 miles south of Birmingham City Centre. The substation consists of 4 no. 132/11kV transformers supplying 4 no. double busbar sections of 11kV switchgear supplied from Kitwell 400/132kV GSP. The substation was constructed in the 1960s but has undergone some modifications and updates.

Figure 2-1 - Original Bournville SLD

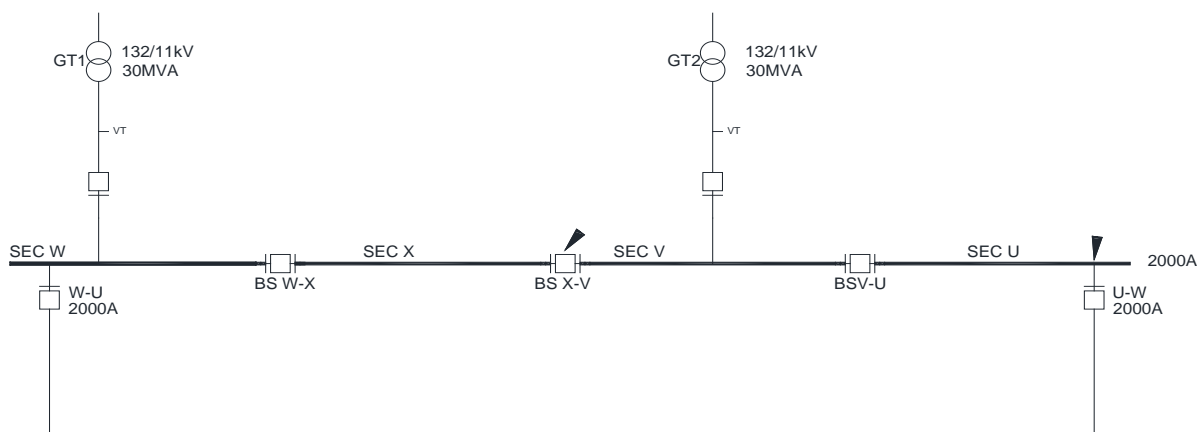
Bartley Green 132/11kV Substation is located around 5 miles to the south west of Birmingham City Centre. The substation comprises 2 no. 132/11kV 30MVA transformers fed from Kitwell 400/132kV GSP via Chad Valley Substation. The 11kV switchgear has recently been replaced and brand new switch-house constructed within the 132kV compound.

Figure 2-1 - Original Bartley Green SLD

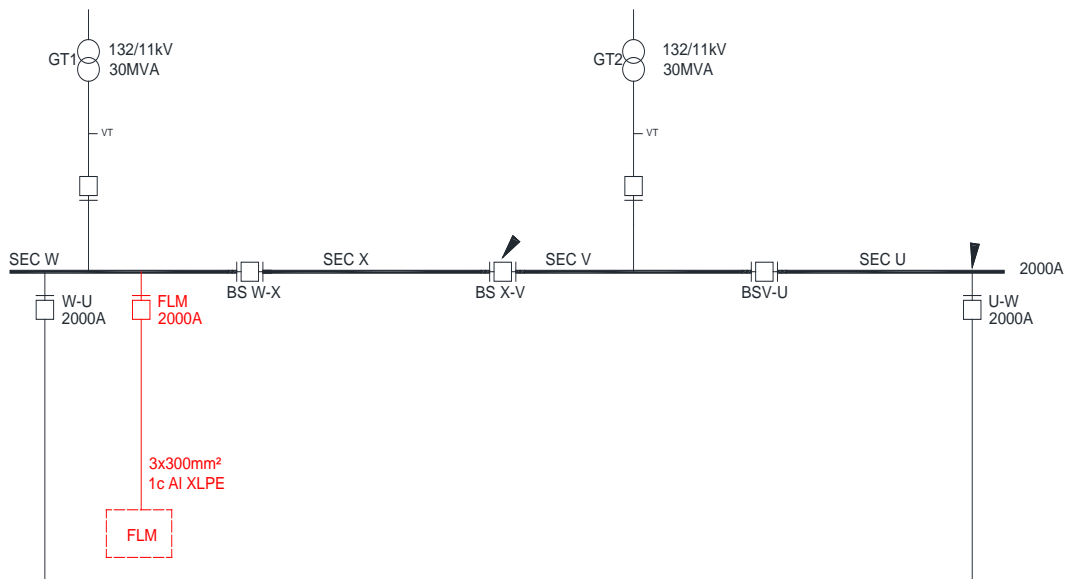
With the installation of a new switchboard, a spare feeder breaker was available for the connection of the FLM. Due to the large size of the 132kV compound space available, the site was chosen for the connection of a Fault Current Limiter also. With this in mind the FLM had to be positioned in conjunction with the FCL to minimise the operational area used and not impact on normal operations within the substation. An area was selected in a corner of the compound opposite one of the grid transformers that is unlikely to be used for any potential upgrades on the 132kV equipment.

Figure 3-1 - SLD of FLM Connection

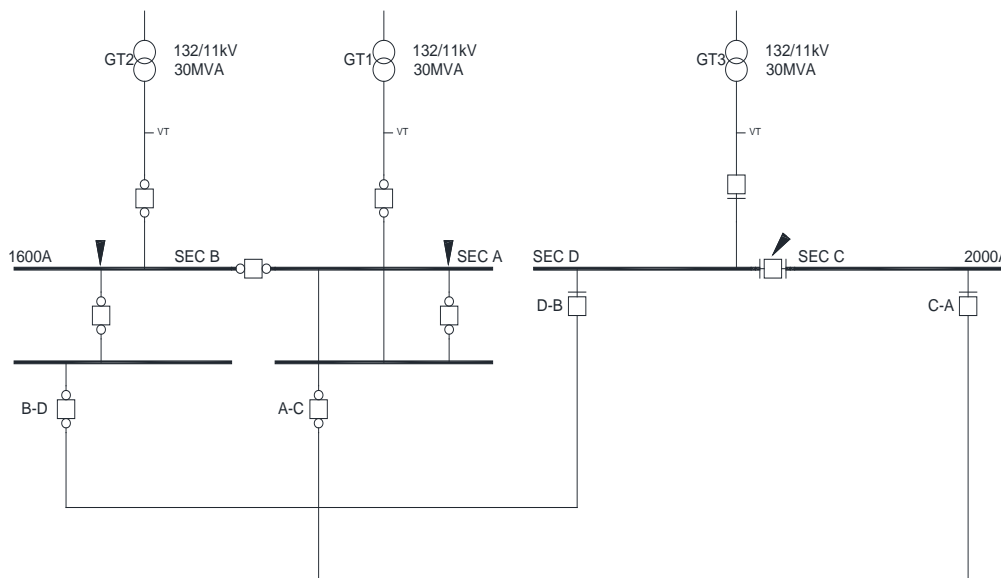
Shirley 132/11kV substation is located around 5 miles to the south east of Birmingham City Centre in a mainly residential and light industrial area. The substation consists of 3 no. 132/11kV transformers with GT1 supplied from Lea Marston 400/132kV GSP and GT2 and 3 supplied from Kitwell 400/132kV GSP. GT1 and 2 supply 2 no. sections of double busbar switchgear installed circa 1965 with GT3 supplying 2 sections of switchgear installed in 2005.

Figure 2-1 - Original Shirley SLD
