OHL Power Pointer - Report on Method 4

Method 4: Directional Fault Detection

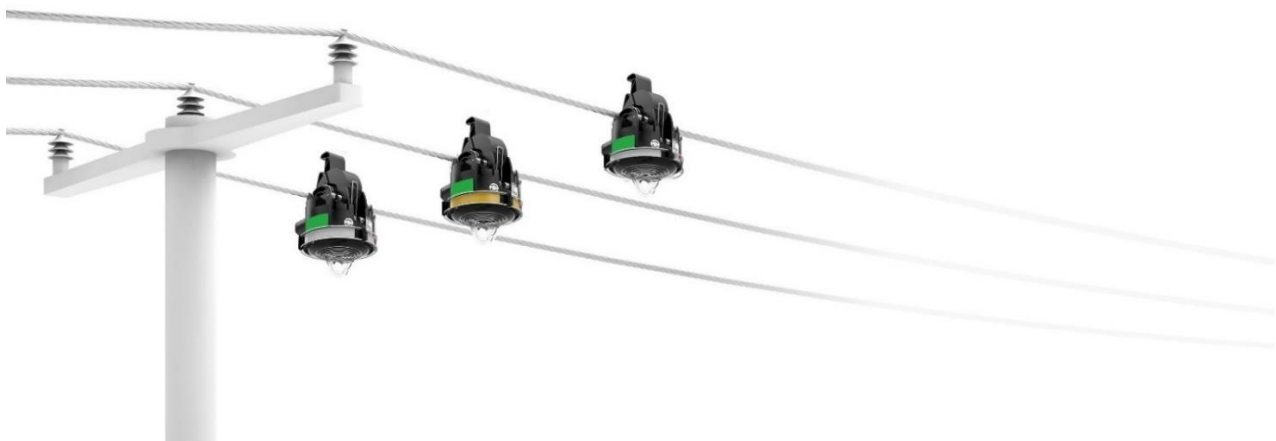
Figure 2-1: Rendered Illustration of a set of Smart Navigator 2.0 sensors

Smart Navigator 2.0 sensors clip onto overhead lines (operating at voltages from 11kV to 132kV) and sample the voltage and current waveforms (multiple times per cycle) to determine the real-time power flow direction at that point in the network. The devices weigh less than 1kg, harvest power from the overhead line for self-sustaining operation and can be readily ported between sites for redeployment. Using encrypted DNP3 communications over mobile networks, the devices transmit power flow data from remote sites to a central system (for example, iHost or PowerOn). The sensors support over-the-air upgrades, which means their functionality can be reconfigured remotely without the need for multiple site visits.

A rendered illustration of a set of Smart Navigator 2.0 sensors installed on a three-phase overhead line is presented in Figure 2-1.

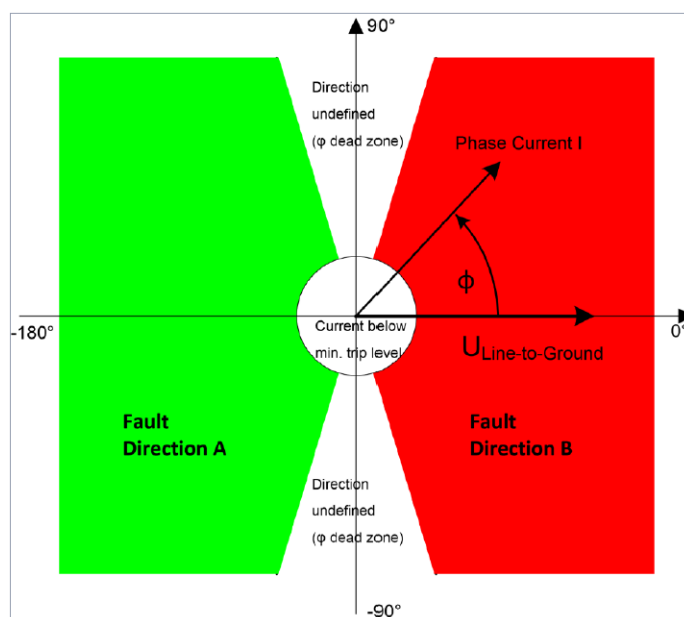
Figure 5-1 – Vector Diagram for Determination of Fault Direction

Each Smart Navigator 2.0 measures the phase angle ϕ between the line-earth voltage and the phase current. From this the unit can derive the fault direction for the phase conductor.

$-90^\circ < \phi < 90^\circ$	Fault direction Red
$-180^\circ < \phi < -90^\circ$ or $90^\circ < \phi < 180^\circ$	Fault direction Green

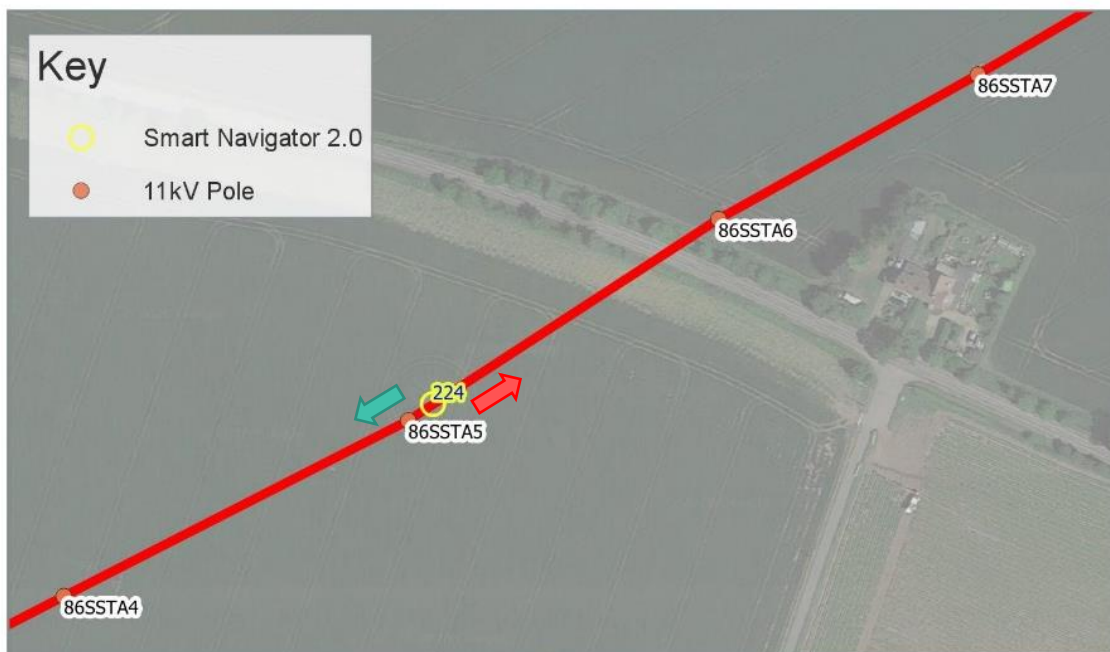
Figure 5-2 –Direction of fault passage through Smart Navigator 2.0 sensors

The Smart Navigator 2.0 sensor records power flow and fault activity using a split core current transformer that is clipped around the OHL. The orientation of the device, and thus the current transformer, on the OHL is critical to interpreting the direction of the power flowing through the circuit. The 'green' and the 'red' sides are indicated on each device with labels to assist with the installation. During the OHL Power Pointer project, the installation convention was to install the 'green' side of the device facing the nearest pole, with the 'red' side pointing along the span towards the far pole, **Figure 5-2** illustrates this concept.

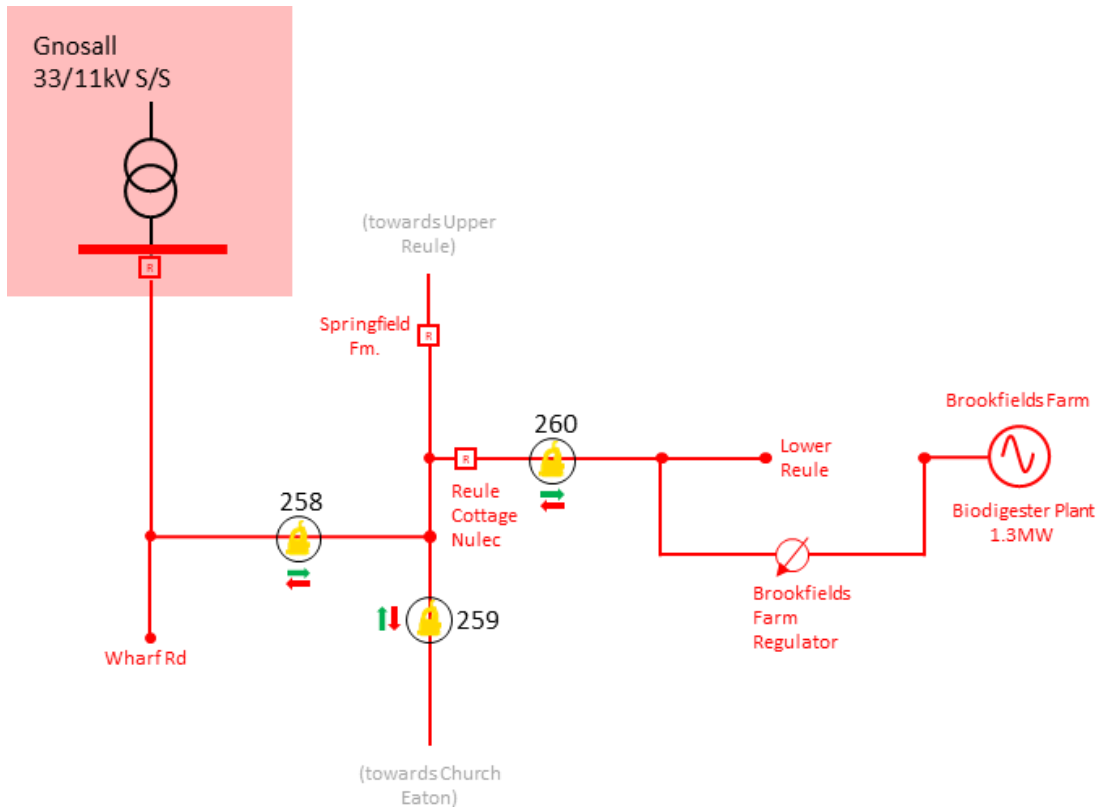
Figure 5-7 – Gnosall Primary Substation and Station Road 11kV Circuit

Lower Reule farm is connected to the Station Road feeder supplied from Gnosall primary substation. A trial site for DFPI was selected which was electrically near to the output of the OCGT, along an overhead section of the feeder, in an attempt to observe fault currents being back-fed into the distribution network. The trial site location is indicated #260 in **Figure 5-7**.

Thirteen fault events were observed along the feeder at trial site #258 during the main field trials. Of these, nine were detected at trial site #259 along the feeder towards Church Eaton. Three were detected at trial site #260.

The events characterised in **Table 5-2** indicate that fault current flowed from the primary substation towards the embedded generator (green direction) during each trip event recorded by the sensor at trial site #260. This suggests that each fault was located between trial site #260 and the generator, or in the generator itself.

If, hypothetically, the generator was to be observed back-feeding into the network, fault current would have been recorded flowing in the red direction at trial site #260. During the incident on the 26th November 2021, fault current was observed to be flowing in the red direction in one phase, and the green direction in the adjacent phases. This is a typical characteristic of a phase to phase fault, where a closed loop is formed between phases, with the current in one affected phase equal to the negative current in the other affected phase.

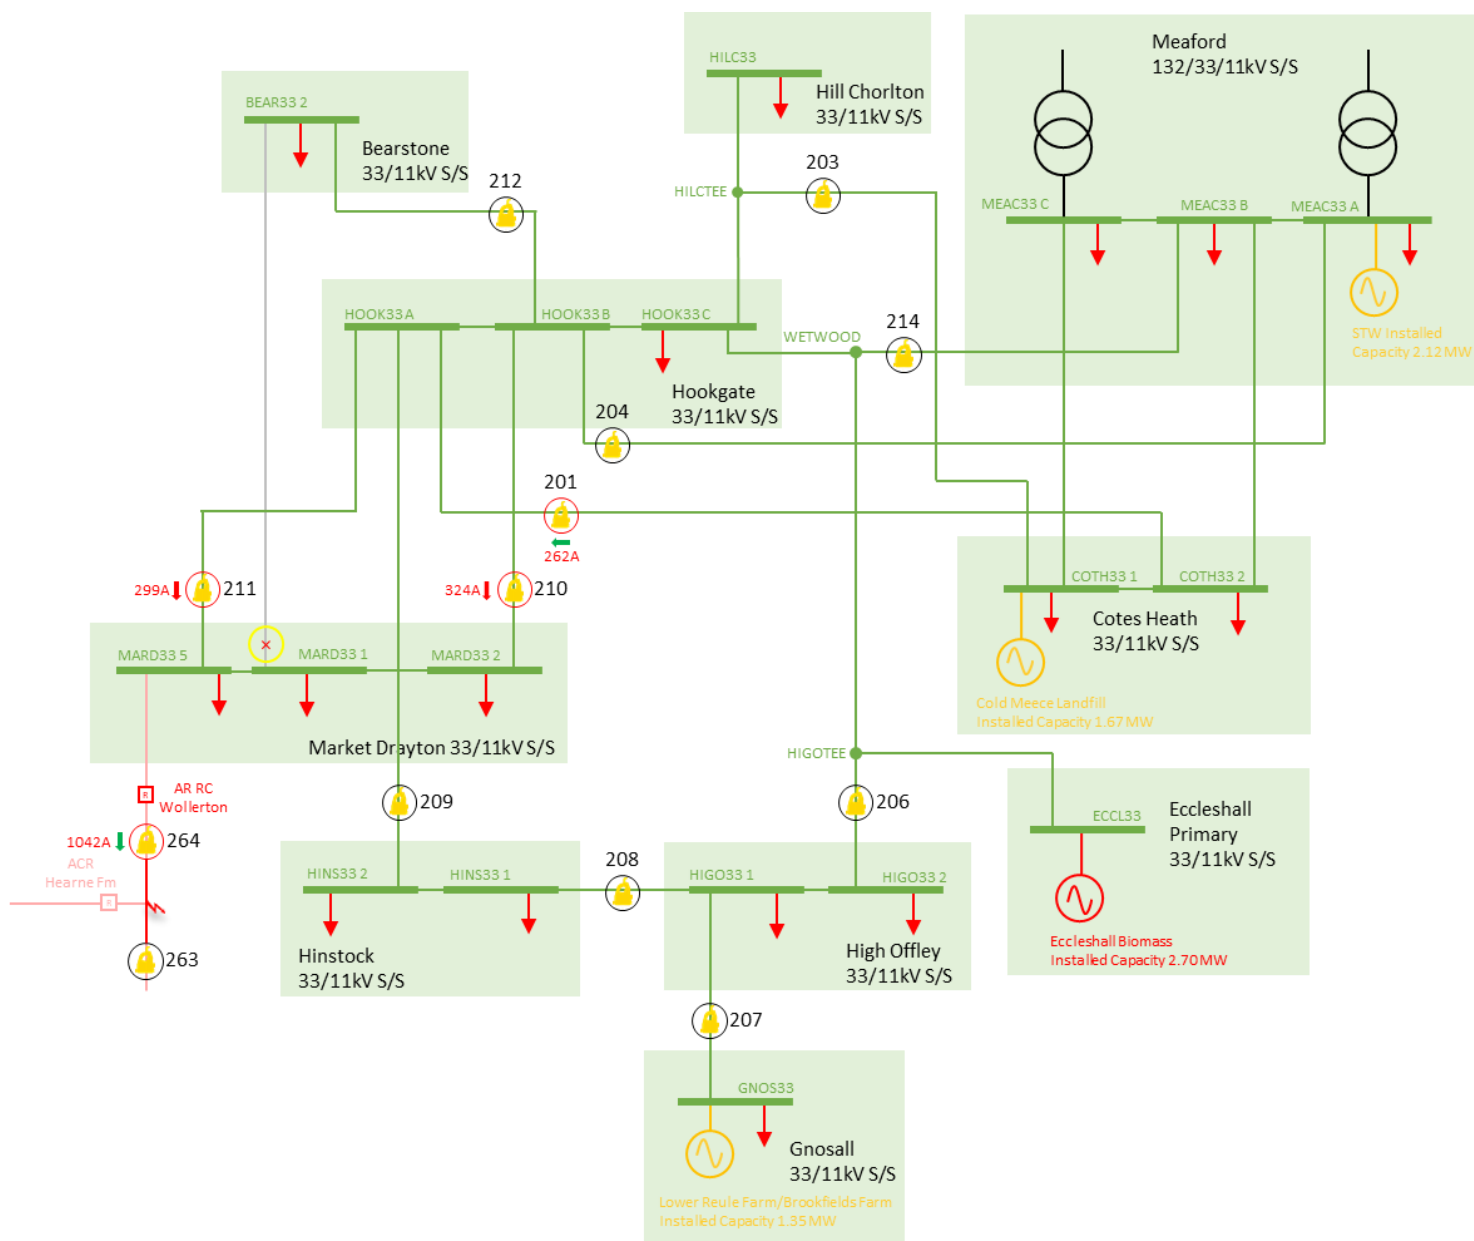
Figure 5-8 – Earth-fault Event on Market Drayton 11kV Feeder

An earth-fault event was detected at trial site #264 on an 11kV circuit supplied from Market Drayton primary substation. The fault occurred at 09:09:09 on 22nd April 2021. The fault was also captured as an overcurrent event by Smart Navigator 2.0 sensors installed at upstream trial sites 201, #210 and #211 on the 33kV primary system. The topology of the 33kV system and the 11kV feeder, with the Smart Navigator 2.0 trial locations is given in **Figure 5-8**. The graphic is annotated with fault current magnitude and the direction of fault passage at each trial location. The colour of the arrows corresponds with the direction convention for the Smart Navigator 2.0 sensors and indicated direction of fault passage at each site.

The fault was located downstream of an auto-recloser at Wollerton, Market Drayton. The recloser history was interrogated through the DNMS and indicated that the circuit-breaker opened (09:09:11) and closed (09:09:16) suggesting one successful circuit breaker reclose action 5 seconds after tripping. The ACR at Hearne Farm was also interrogated, this equipment did not detect the fault. Trial site #263 did not detect a fault but recorded a temporary voltage loss on the circuit and the timing of this event coincided with the upstream auto-reclose operation.

The location of the earth-fault was successfully indicated in the 'green' direction by the sensors at trial site #264, the fault characteristics are presented in **Table 5-3**.

Upstream from the fault, on the 33kV network, trial sites #201, #210 and #211 recorded overcurrent events, with fault passage indicated in the direction of Market Drayton primary substation from Meaford BSP. This would suggest a large fault infeed from the 132kV system, which is typical of a conventional distribution topology.
