# EDGE-FCLi

Performance Report  
April 2022

The Embedded Distributed Generation Electronic Fault Current Limiting interrupter (EDGE-FCLi) project is funded through Ofgem's Network Innovation Allowance (NIA). EDGE-FCLi was registered in September 2018 and is now in the closedown phase.

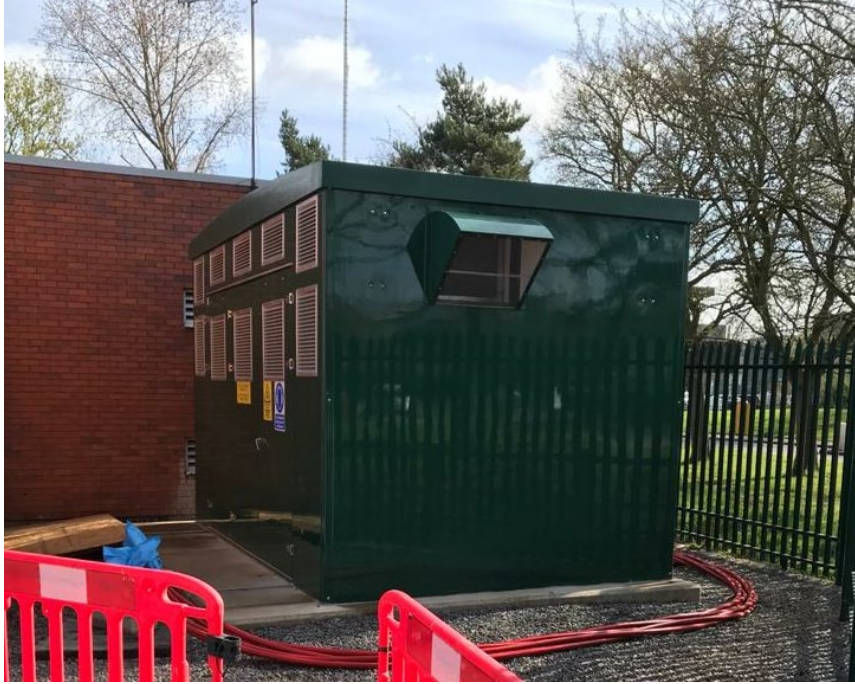
The EDGE-FCLi is designed to be located indoors or within a GRP housing to protect it from the external environment. Figure 2-5 shows the GRP housing used for the EDGE-FCLi at the University of Warwick 33/11kV substation. For an indoor installation, the device would need to be installed in a purpose-built outhouse or room within the primary substation that can be locked off to avoid unauthorised personnel access.

Figure 2-5 EDGE-FCLi GRP housing at UoW 33/11kV substation

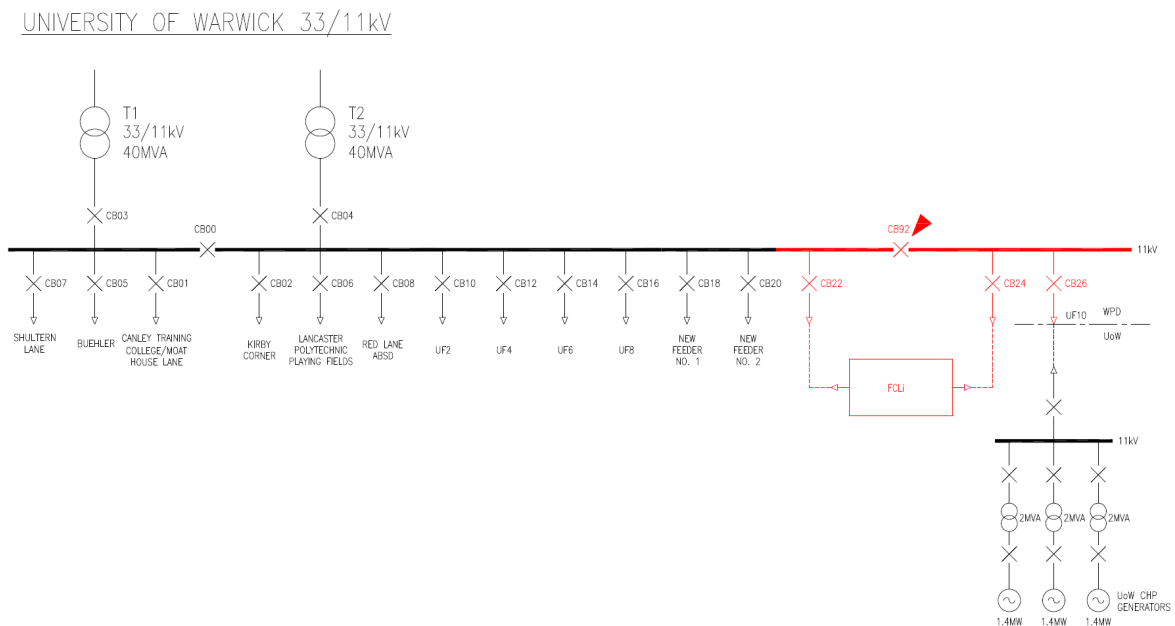
The trial site for the installation of the EDGE-FCLi was the 33/11kV University of Warwick (UoW) primary substation. The site was selected due to its proximity to three 1.4MW CHP machines that supply electricity and heat to the local university campus. The device was connected in series with the UoW CHP generators fed from 11kV circuit breaker “CB26”. A new four panel 11kV switchboard extension has been installed to provide control, protection and by-passing of the EDGE-FCLi. Figure 2-6 below shows the single line diagram of the connection with the new equipment shown in red.

Figure 2-6 Final single line diagram of 33/11kV UoW substation

The bus section circuit breaker CB92 was included in the design to allow the EDGE-FCLi to be bypassed and keep the customer connected under an EDGE-FCLi outage. This configuration is acceptable at the UoW as the site does not have a fault level limitation and a bypass is prudent for the innovation trial. However, at locations where the fault level is a concern, the use of a bypass circuit breaker should be reviewed.

A protection trip signal received from the EDGE-FCLi, either due to an internal device fault or a fault detection operation, will automatically initiate opening of CB22, CB24 and CB26 11kV circuit breakers.

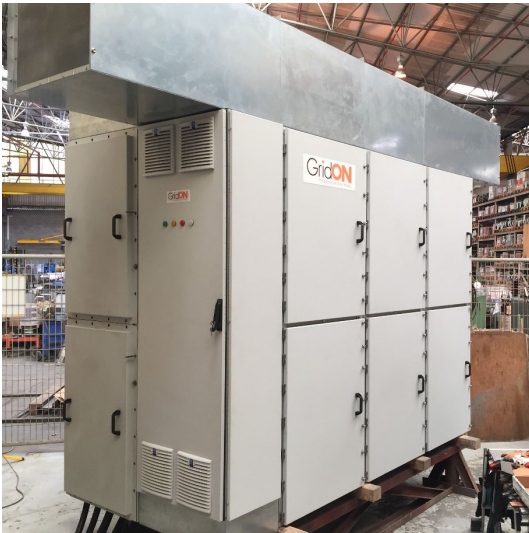
Figure 3-1 FCLi during FAT test in Israel

The FCLi performed well during the FAT. Most notably, the device passed the 95kV Lightning Impulse (LI) tests as well as the temperature rise test. It was observed that the forced air-cooling system was able to keep the Insulated-gate Bipolar Transistor (IGBT) heat sink temperatures well below the maximum levels at the rated load current (328A).

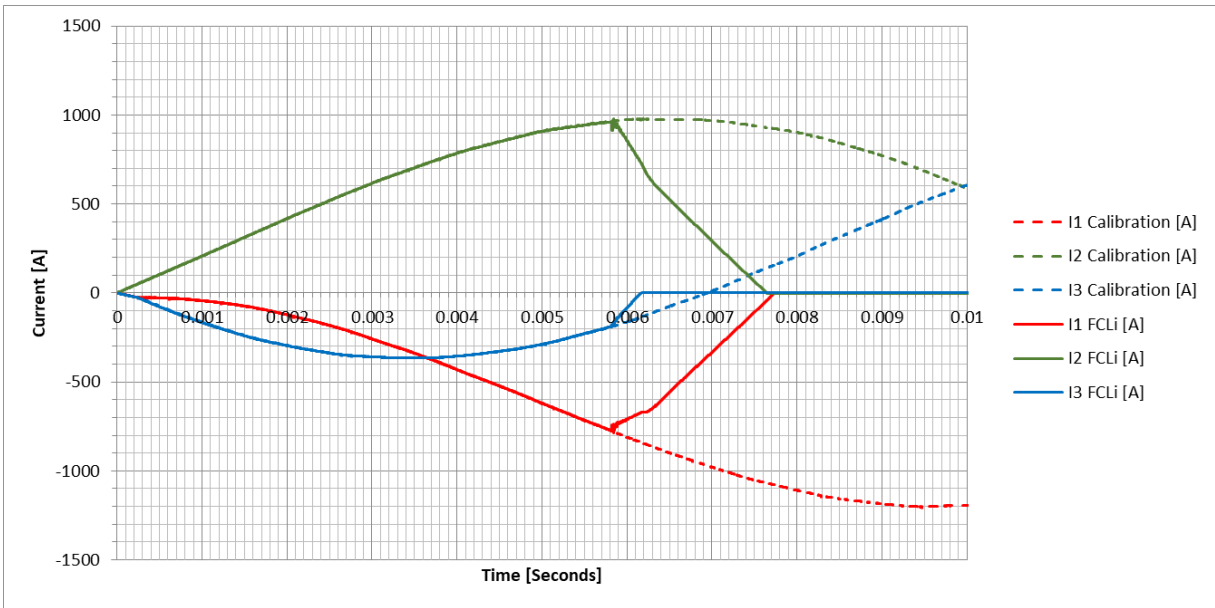
Figure 3-4 shows the FCLi interrupting the 460A RMS prospective current. The current interruption can be seen in the green line. Figure 3-5 shows the FCLi interrupting the 460A RMS prospective current with the non-default setting. The current interruption can also be seen in the green line. Throughout the testing the FCLi correctly interrupted the short circuit current at both fault detection settings.

Figure 3-4 3ph 460A RMS prospective current – detection thresholds setting 1

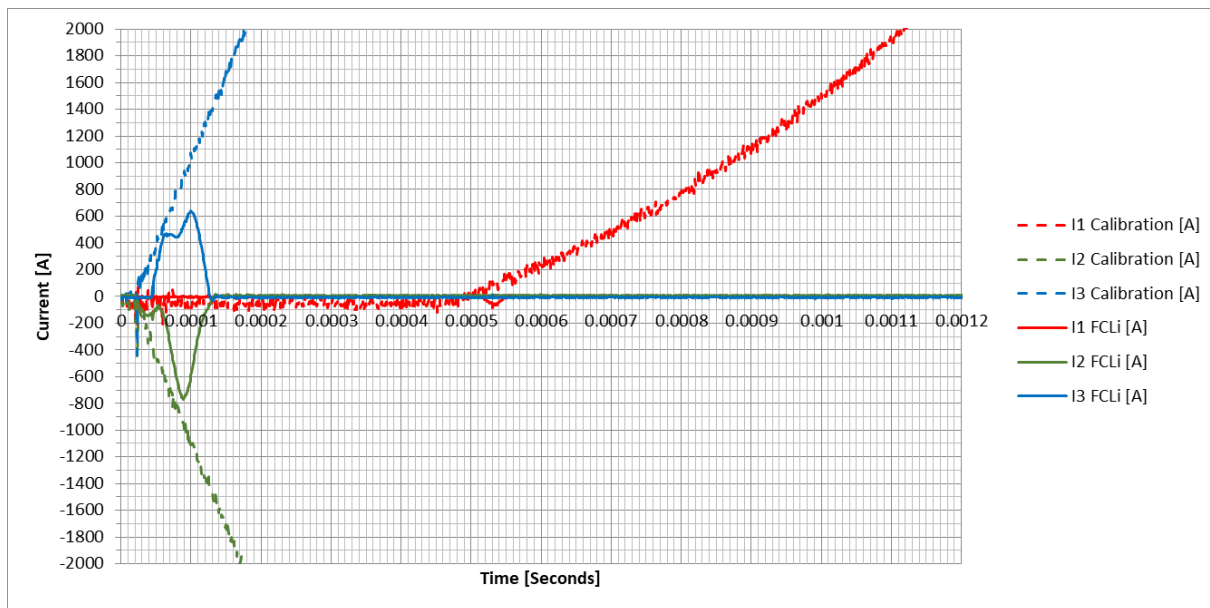
The FCLi operates very rapidly under very close-in faults i.e., a fault at the generator terminals. Figure 3-6 shows the device undergoing a 25kA RMS prospective current test. The device operated in less than 200µs from the initiation of the short circuit current.

Figure 3-6 3ph 25kA RMS prospective current – detection thresholds setting 1 (zoomed in on x-axis)

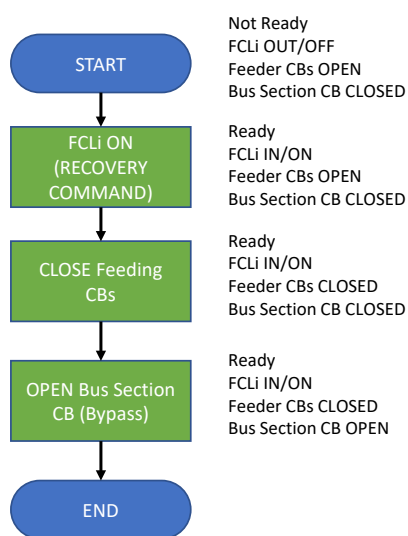
Figure 4-3 and Figure 4-4 below show examples of the simplified control flowcharts that were used to guide the redefinition of the operational modes.

Figure 4-3 EDGE-FCLi remote switch on flowchart

The control engineers' main concern was that the "IDLE" and "RECOVERY" mode labelling on the control screens was significantly different to traditional network equipment, which could cause some misunderstanding when trying to operate the device remotely. To improve the telecontrol functionality, a set of simplified operational flow charts were produced based on the existing EDGE-FCLi's operational modes. These flow charts were then shared and refined based on the feedback received from control. The EDGE-FCLi has two main operational modes that can be executed from the control centre. The first is "RECOVERY" mode, which closes the IGBT switches in the device, making it ready to be energised at 11kV. The second original telecontrol was the "IDLE" mode, which opens the IGBT switches in the device and puts the device into a 'sleep' state. We have now redefined these modes as "ON" and "OFF" respectively, to make it clearer and simpler for the control engineers to interpret the function of the modes.
